Management of erosion of inflatable penile prosthesis reservoir into bladder. A different approach

Department of Urology, Faculty of Medicine, University of Çukurova, Adana, Turkey.

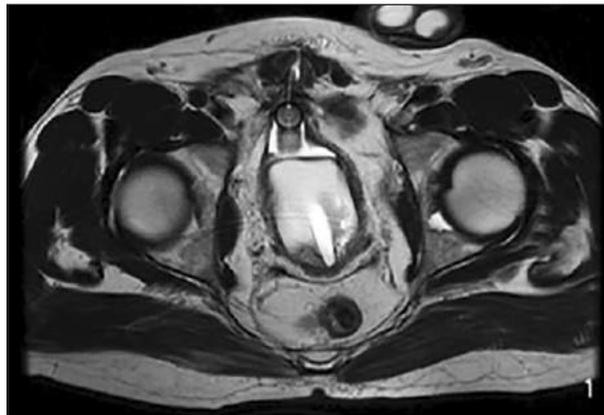
Figure 1.
MR scan showing erosion of the reservoir into bladder.

A 54-year-old male patient underwent a robot-assisted radical prostatectomy operation due to localized prostate cancer two years before our observation. Because of erectile dysfunction after operation, the patient received sildenafil therapy without benefit from the treatment, so inflatable penile implant was placed in another center. Two months after the operation, the patient referred to our clinic with predominant symptoms of lower urinary tract system associated with scrotal pain and swelling. On physical examination, the right testicle was normal at palpation with minimal hydrocele and penile prosthesis was detected. Left testicle was normal and minimal hydrocele was observed. Scrotal ultrasonography reported a bilateral complicated chronic hydrocele. Laboratory findings showed at urinalysis the presence of 1605 leukocytes, with positive leukocyte esterase (++) and nitrite (+); blood count showed WBC 6900/mm³; serum procalcitonin level was 0.09 n/ml and erythrocytes sedimentation rate (ESR) 59 mm/h; urine culture was negative. Meropenem 500 mg ter in die treatment was started after consultation with *Infectious Diseases and Clinical Microbiology* clinic. In addition to antibiotic therapy, diclofenac sodium, scrotal elevation and cold application were also provided. Despite the treatment, due to the persistence of the patient's complaints, urinary system ultrasonography (USG) and lower abdomen magnetic resonance imaging (MRI) were performed and it was demonstrated that the reservoir of the penile prosthesis was in the bladder (Figure 1). Cystoscopy confirmed the presence of the reservoir in the bladder.

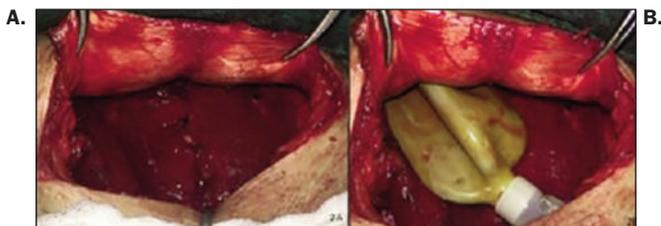
Figure 2.
A. Space was created between the rectus muscle and the skin.
B: The reservoir was placed in the space formed.

A Pfannenstiel incision was made to expose the bladder and perivesical space and the bladder anterior wall was released, to reach where the reservoir entered in the bladder. The bladder wall was opened to remove the reservoir and after that bladder repair was performed. After bladder repair, the rectus muscles were repaired and a space was created between the rectus muscle and the skin (Figure 2A). The reservoir was kept in saline

with diluted 180 mg of gentamicin for 10 minutes. Then the reservoir was placed in the space formed (Figures 2B-3). After the operation, the patient was treated with vancomycin and meropenem for 2 weeks. After postoperative observation, the patient was discharged without any infection and regression of symptoms of lower urinary tract. No problem in using the penile prosthesis was reported by the patient at 1-month and 3-month follow up. The patient was not uncomfortable in this regard because the patient's reservoir was not visible under the skin and *computed tomography* (CT) at 3 months did not show any infection status or abscess around the reservoir (Figure 4).

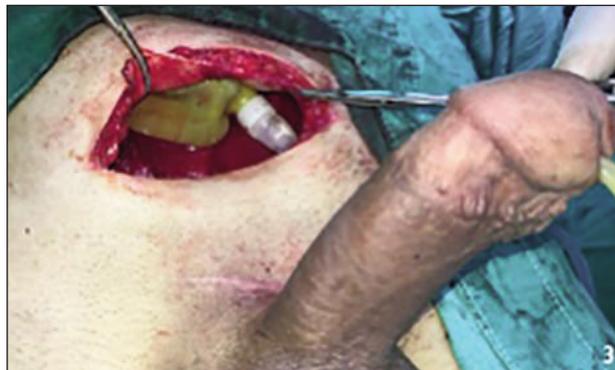
Figure 3.
The reservoir was placed in the space formed and semirigid penile erection was obtained.

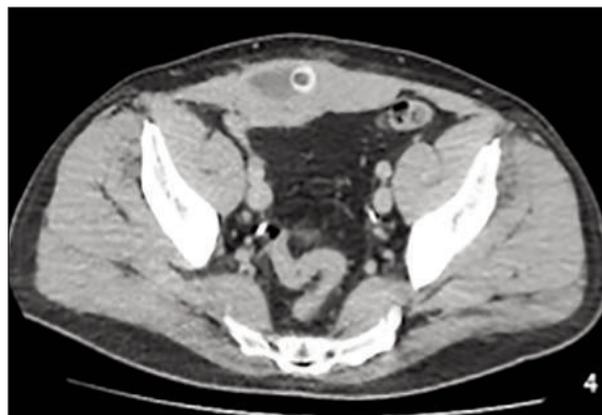
Figure 4.
CT scan at 3 months after operation showing the reservoir in the area formed without problem.
