Surgical repair of the iatrogenic false passage in the treatment of trauma-induced posterior urethral injuries

Faruk Doğan¹, Ali Feyzullah Şahin¹, Tefik Sarıkaya², Alper Dırık¹

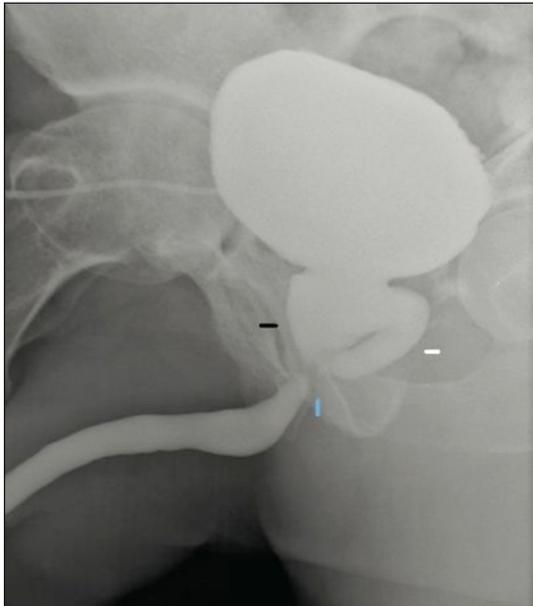
Figure 1.

Preoperative VCUG and RUG shows the location of a false passage and urethral stricture. The black arrow shows normal bladder neck and prostatic urethra, the blue arrow shows the urethral stricture and the beginning of the intraprostatic false passage, while the white arrow shows the false passage located close to bladder neck.

A cystostomy catheter was placed. After observing the site and distance of the posterior urethral stricture with *combined cystourethrography* (CCUG), a picture consistent with intra-prostatic false passage was detected (Figure 1).

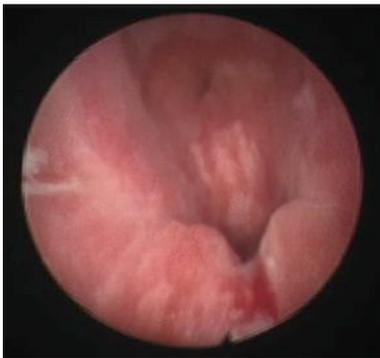
Figure 2.

Flexible cystoscopy performed via suprapubic route, shows the false passage close to the bladder neck in the upper tract and the lower wide tract shows prostatic urethra.

False passage and desired passage were assessed by performing antegrade urethroscopy with flexible cystoscope through the cystostomy tract and simultaneous retrograde urethroscopy through the urethra under general anesthesia (Figure 2 and 3).

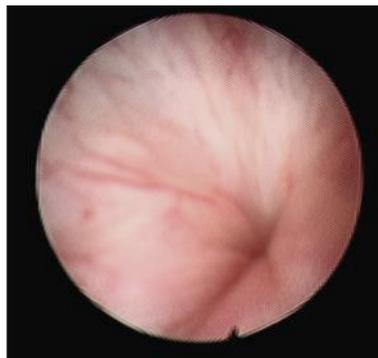
Figure 3.

A closer view of the false passage formed by a circular dense scar tissue.

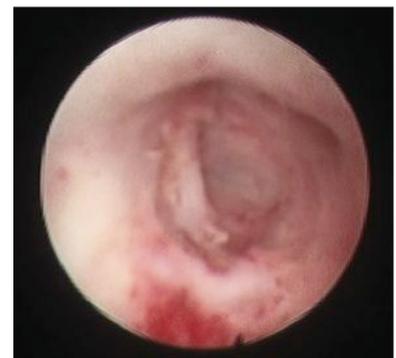
Figure 4.

The distal part of veru montanum of the prostatic urethra is completely obliterated.

By advancing a guidewire through the flexible cystoscope, the *veru montanum* was localized and the part past the external sphincter was found to be totally closed

(Figure 4). At the same session, transperineal urethroplasty was initiated in the lithotomy position. Complete urethral mobilization until the site of stricture was performed via perineal incision for primary anastomosis urethroplasty.

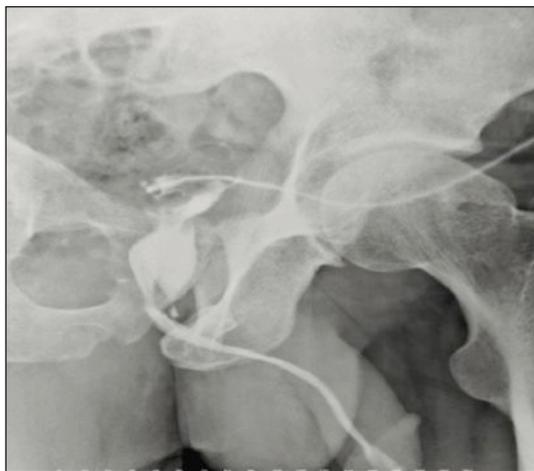
Figure 5.

Postoperative RUG shows an anastomosis without stricture between prostatic urethra and proximal distal urethra, and a false passage ending with a dead end.

The patient was followed up for 1 year. Urethral catheter was removed at postoperative week 3. By performing CCUG, the patent anastomosis and the false passage ending with a dead end between prostatic urethra and proximal urethra were observed (Figure 5).

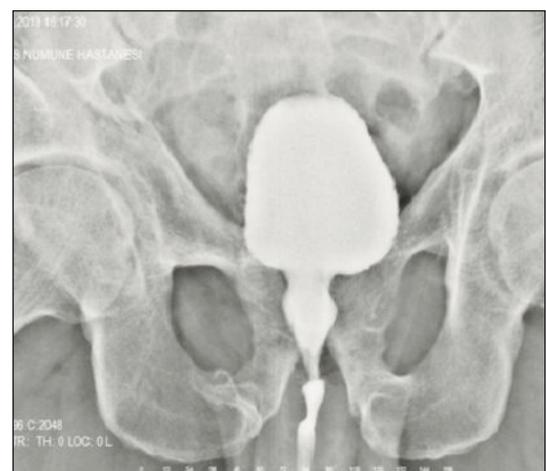
Figure 6.

False passage disappeared one year after surgery.

Urethral false passage disappeared one year after surgery (Figure 6).
